# Manhole Inspection Summary

Manhole # S06AA2009MH

Insp Date: **6/23/06 9:51 AM**

**Location** Address: **6905 DORSET PL**

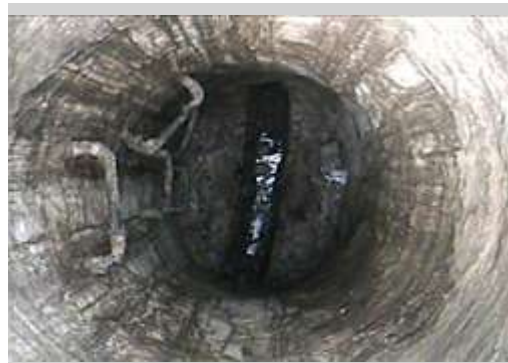
Top View

Comments **Even though this MH has previously been rehabbed, there is still a pretty good amount of infiltration entering. The I7 pipe picture shows Channel deterioration.**

Adjustment and Corbel infiltration. Bench debris.

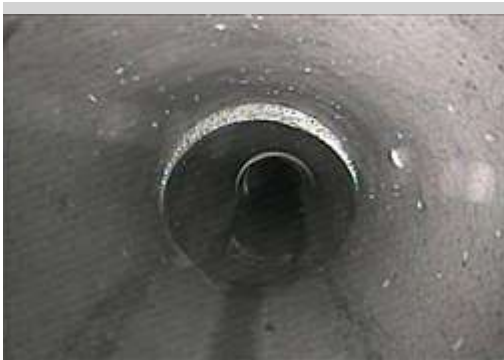
Inside of the O12

Joint Offset O12

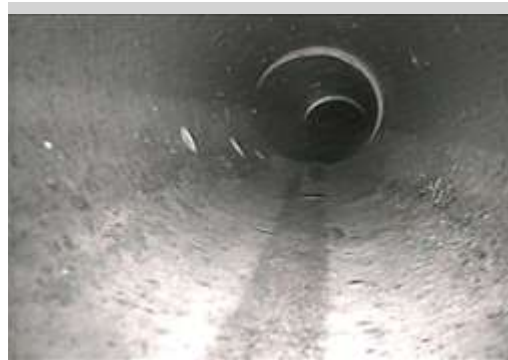
Inside of the I6

Joint Offset I6

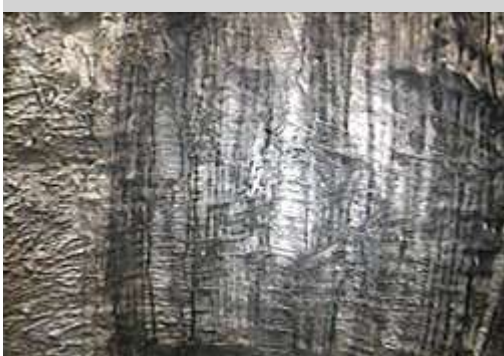
Defect

Adjustment and Corbel infiltration.

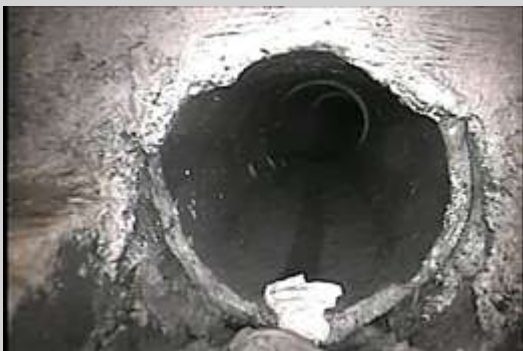
### 8 in. Circular Gravity Sewer Pipe In @ 6 O'Clock

Infiltration: **Evidence** Pipe Seal Cond: **Unknown**
